OPERATION SNAPPER. TEST CONDUCTED AS PART OF
EXERCISE DESERT ROCK IV.
MAY-JUNE 1952

THE SUSCEPTIBILITY TO DAMAGE AND THE PROTECTION AFFORDED BY QUARTERMASTER ITEMS

I. Clothing
II. Clothing Fabrics
III. Protective Cream
IV. Packaging

JOHN M. DAVIES
Philadelphia QM
Research and Development
Laboratories

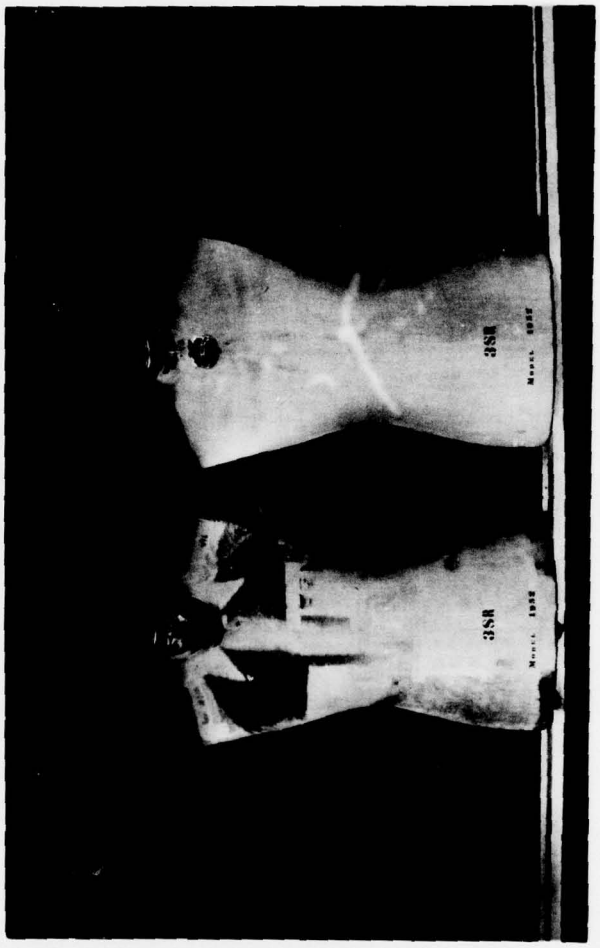
Fig. 3.22 Scorching of Dummies under Hot Wet and Hot Dry Ensembles, 1 Mile, Shots 6 & 8

for small effects of the blast the photographs of samples at 1-1/2 miles generally will serve to indicate the condition of all the clothing before exposure. The scorching of the dummies and under layers is shown in Figures 3.22 and 3.23.

The highest temperatures recorded were probably below the limit for second degree burns if the 141°C figure is accepted. However, the scorching of the dummies and underwear indicates that the maximum temperatures were above the maximum recorded. The hot dry and hot wet ensembles do not provide adequate protection at 10 to 13 langleys where there is only a single layer of the outer fabric but they do in multilayer

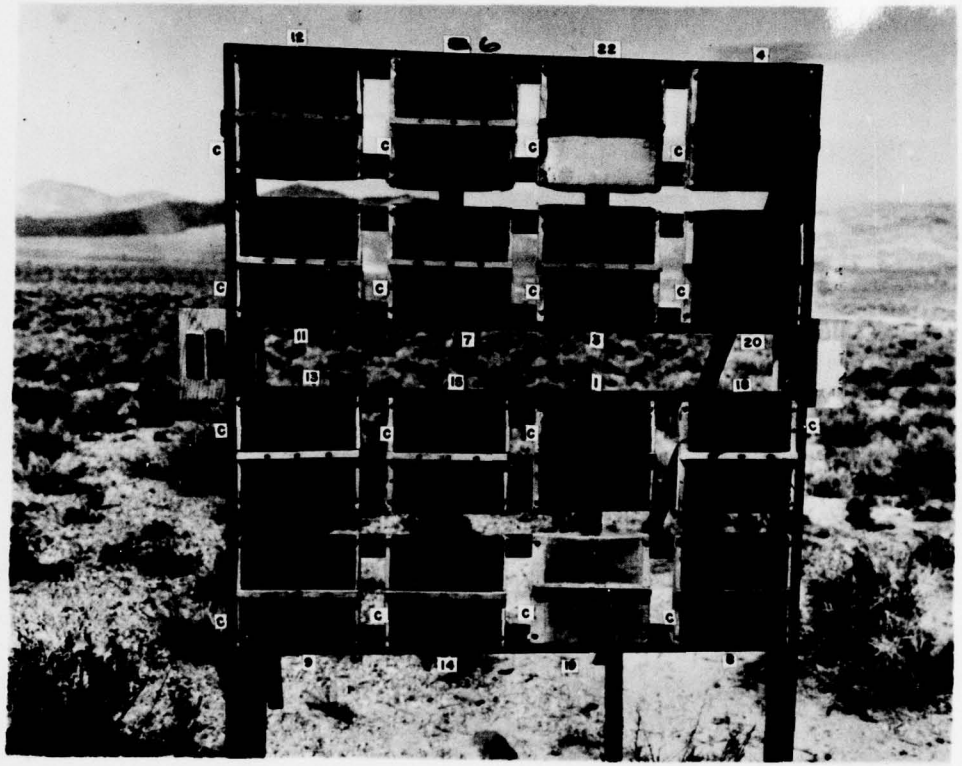
Fig. 4.1 Fabrics on Panels - Shot 6 - 1-1/2 Miles

Photographs of the panels are shown in Figs. 4.1 to 4.4. With few exceptions there was little or no damage at 5 langleys and the materials before exposure were essentially the same as after exposure at 1-1/2 miles.

There was very little damage at 4 to 5 langleys. The only visible effect was on the following:

Sample 5, some damage to the nylon of the cotton warp-nylon filled oxford, rating 111.

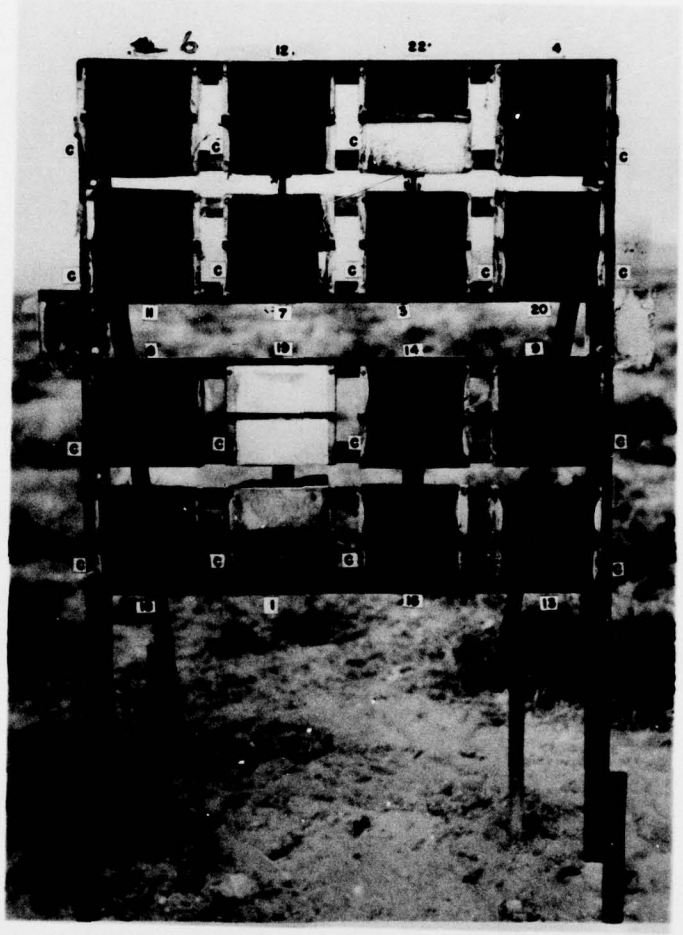
Fig. 4.2 Fabrics on Panels, Shot 6, 1 Mile

The damage to fabrics on the panels was about the same as the maximum damage to the same fabrics as clothing. The nylon filled cotton warp oxford on sample 5 was slightly damaged at 5 langleys and completely destroyed at 13 langleys.

The undyed sateen, sample 10, was much more resistant than either OD-7 or OG-107 with no perceptible damage at 13 langleys. Dyed samples were almost completely destroyed at that intensity. The aluminized fabric showed no damage up to 10 langleys.

There were slight but apparently definite differences between standard and camouflage shades. For cotton, OG-107, e.g., sample 8, was damaged more than OD-7, sample 9. For wool, OG-108, sample 13, was damaged more than OD-33, sample 14.
